Photo 1: Overview of the rear of the Facility. Taken 5/26/15.

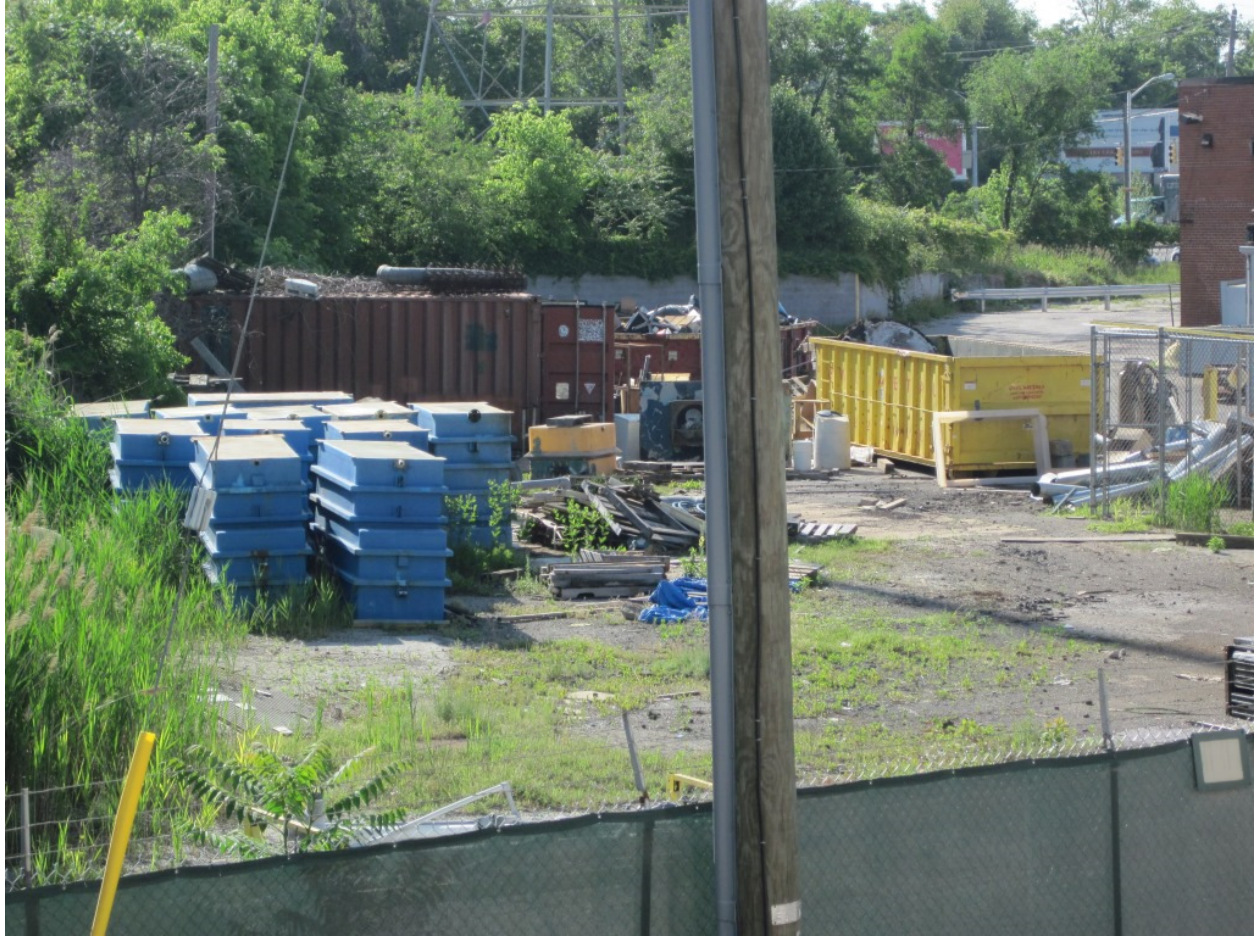
Photo 2: Overview of the rear of the Facility. Taken 5/26/15.

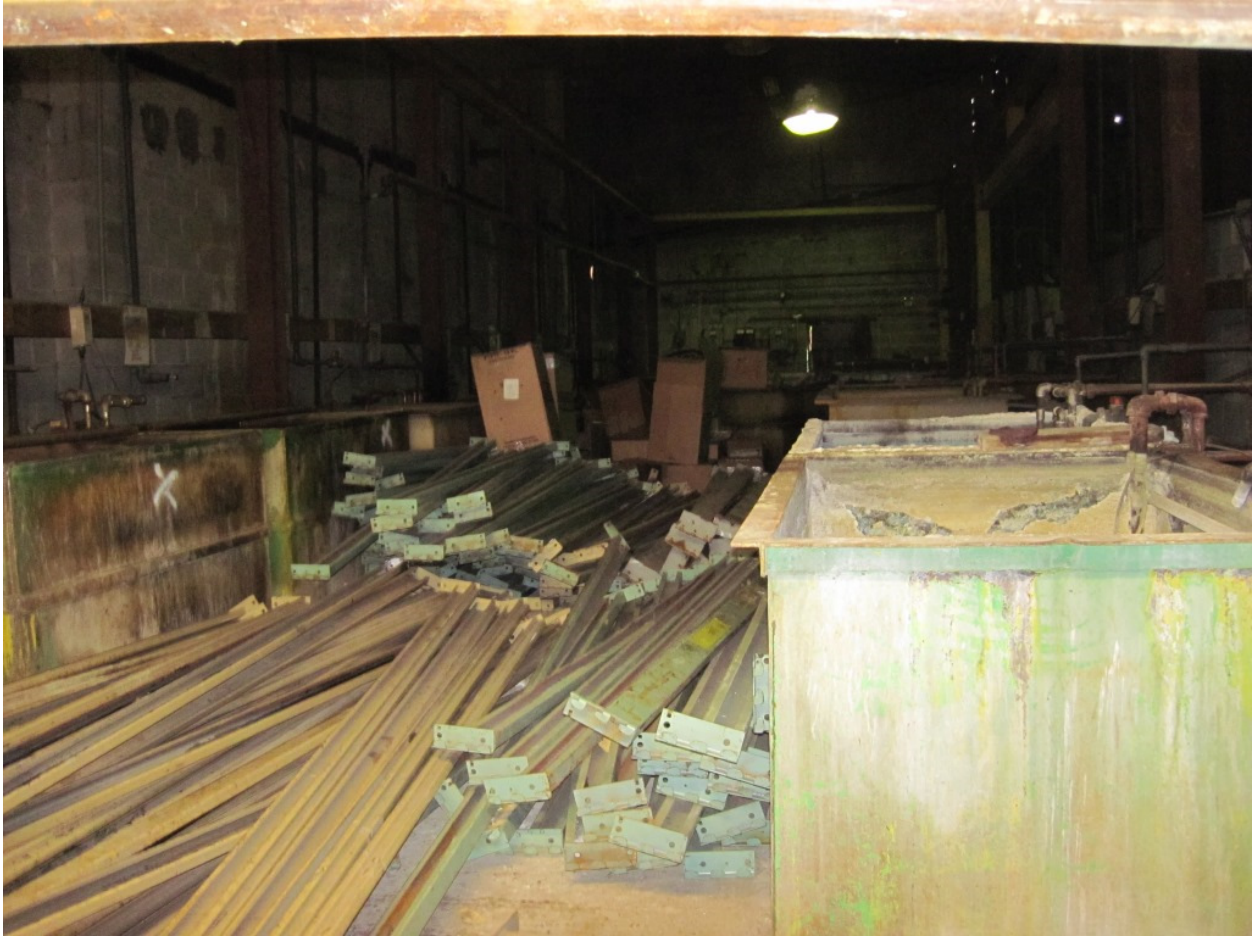
Photo 3: Overview of the intact anodize line in the Anodize Department.

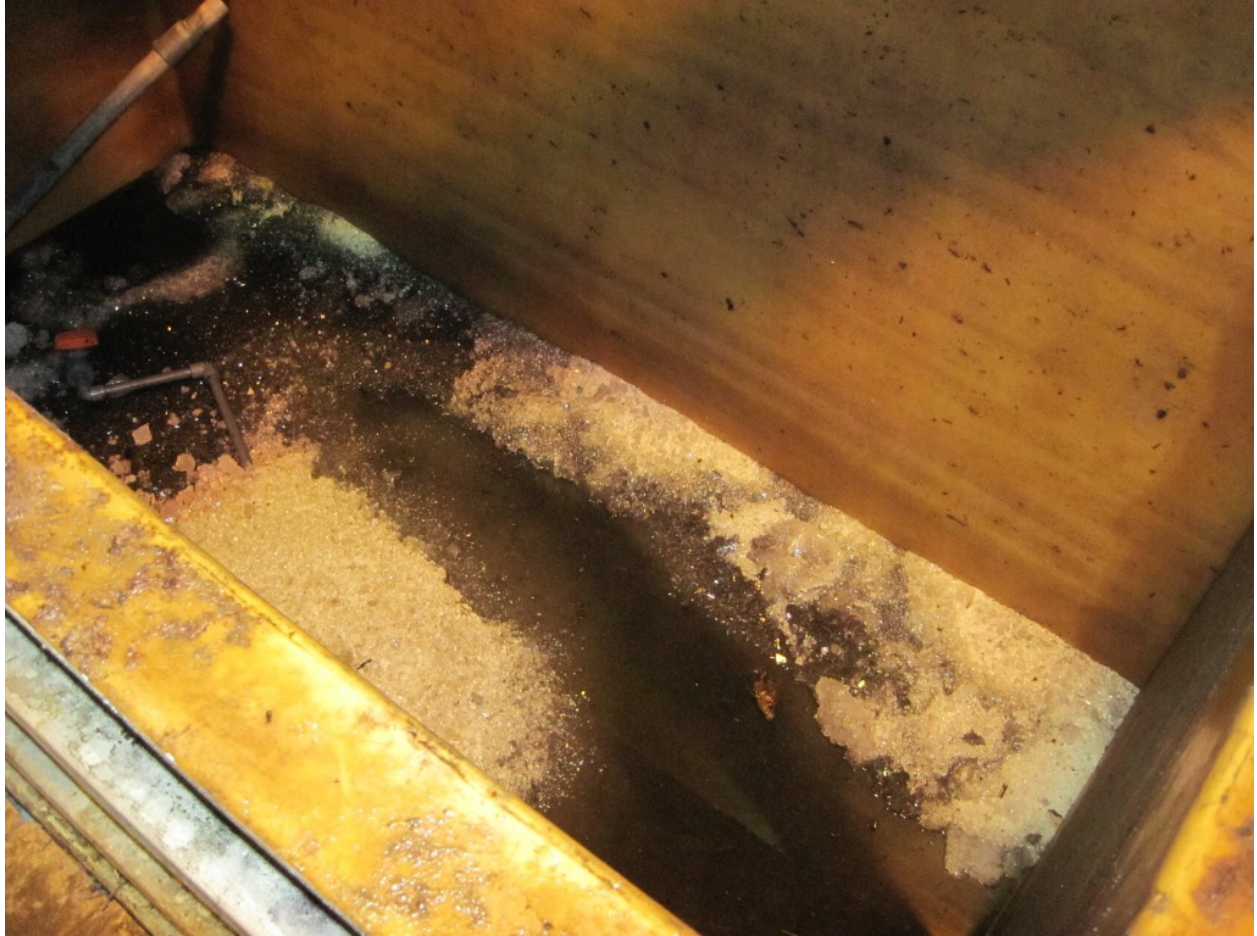
Photo 4: Close-up of solid sulfur crystals formed in a tank in the Anodize Department. The tank formerly contained sodium hydride and sulfuric acid.

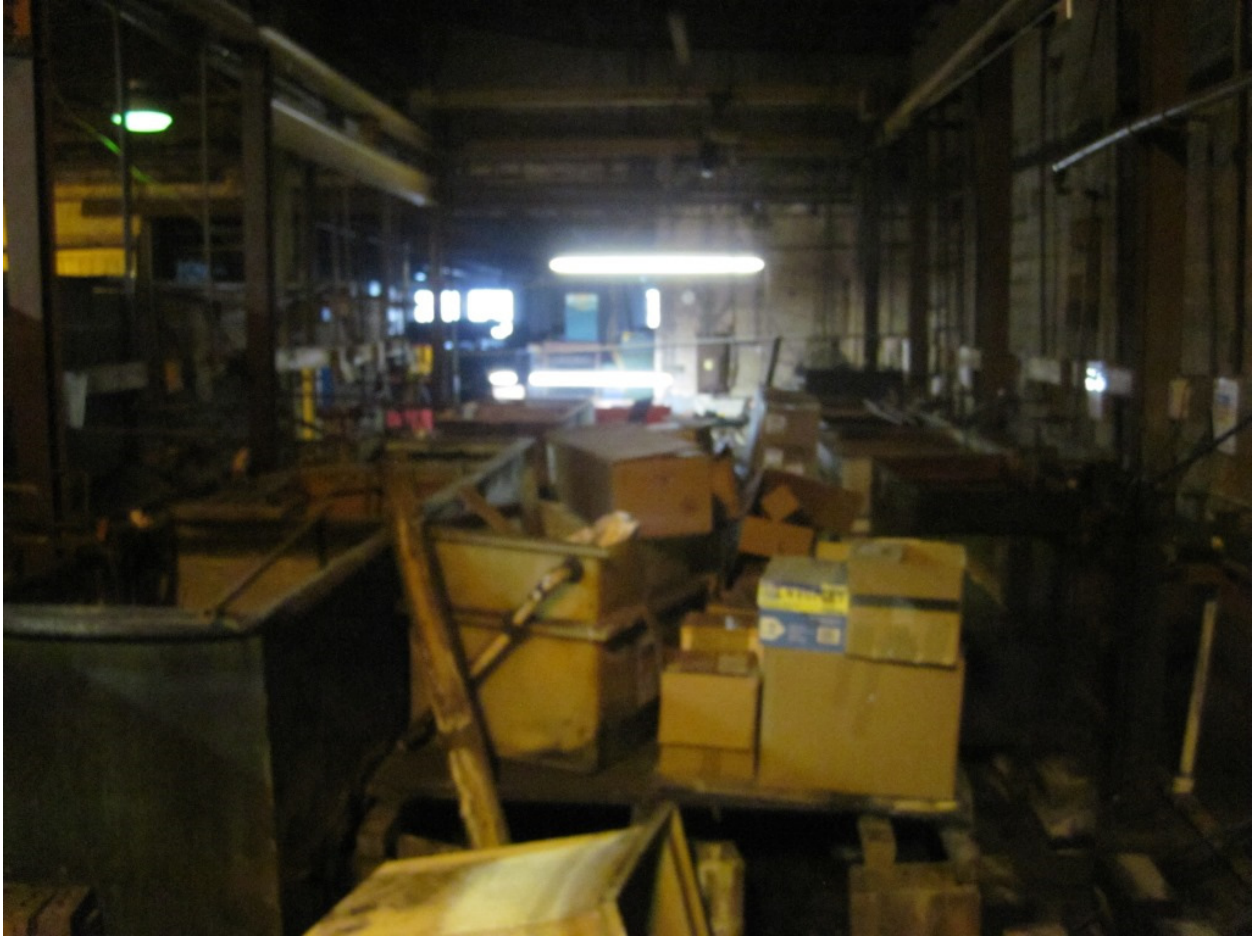
Photo 5: Overview of Anodize Department.

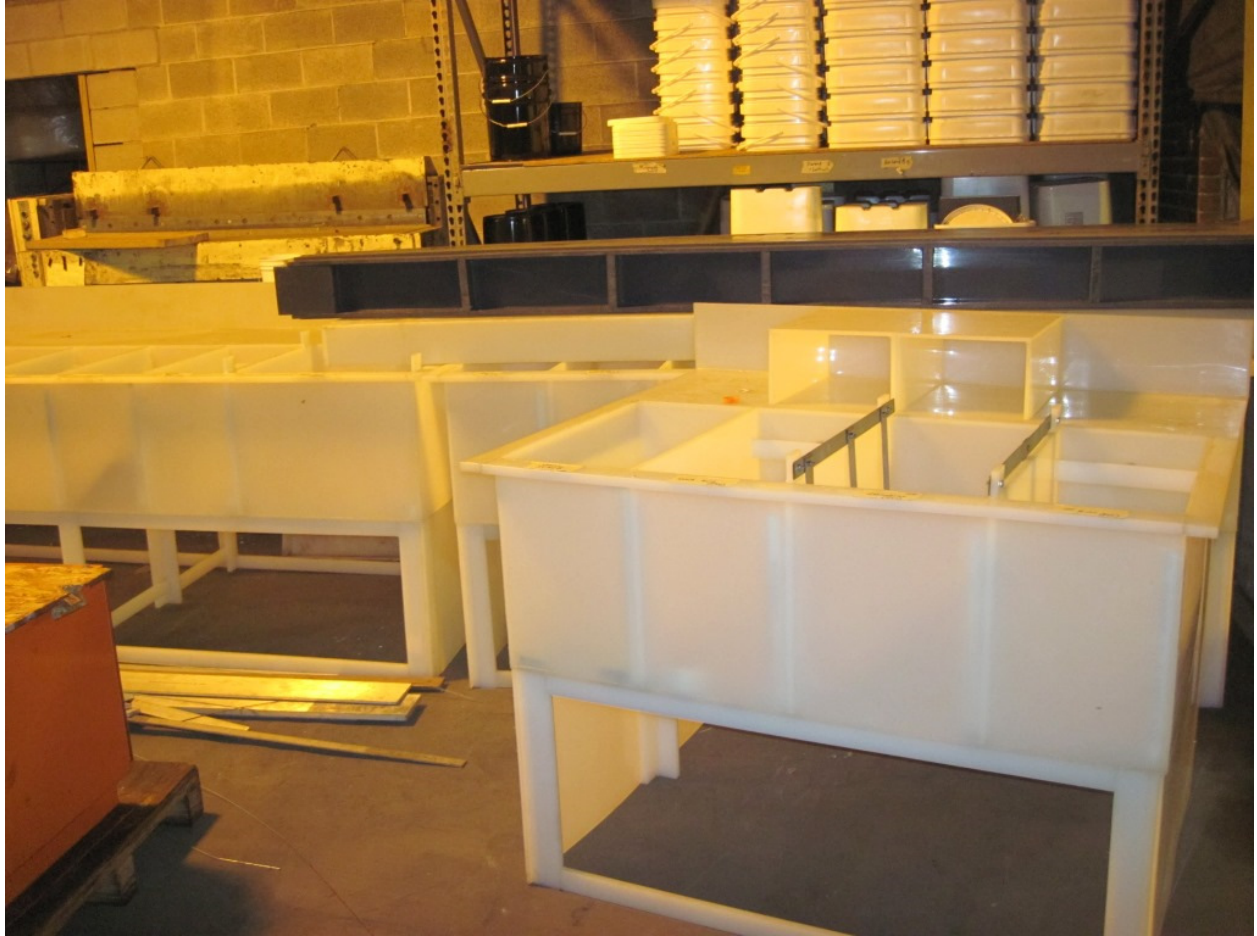
Photo 6: Fabricated plastic plating lines.

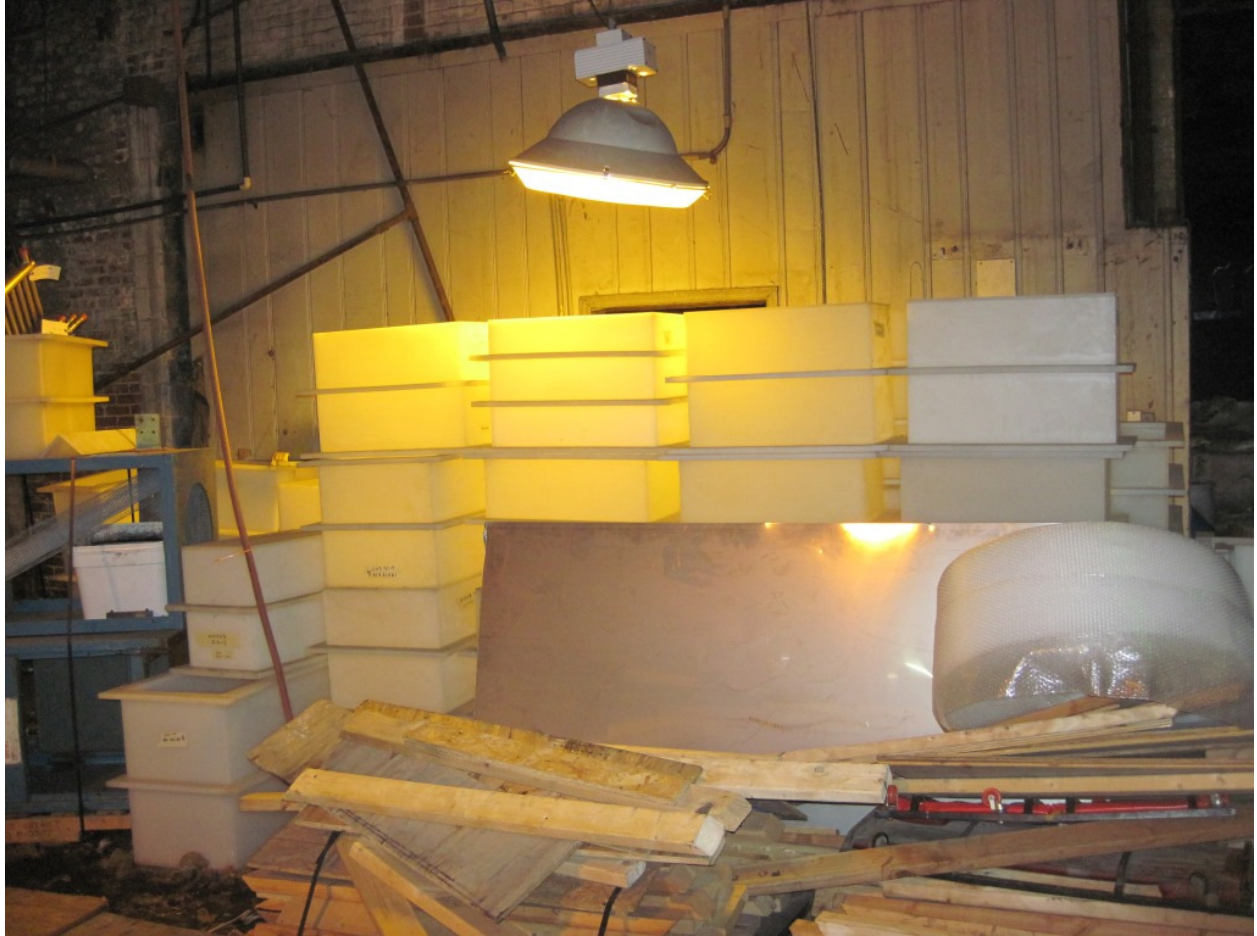
Photo 7: Overview of Mr. Nagy's fabricated plating tanks.

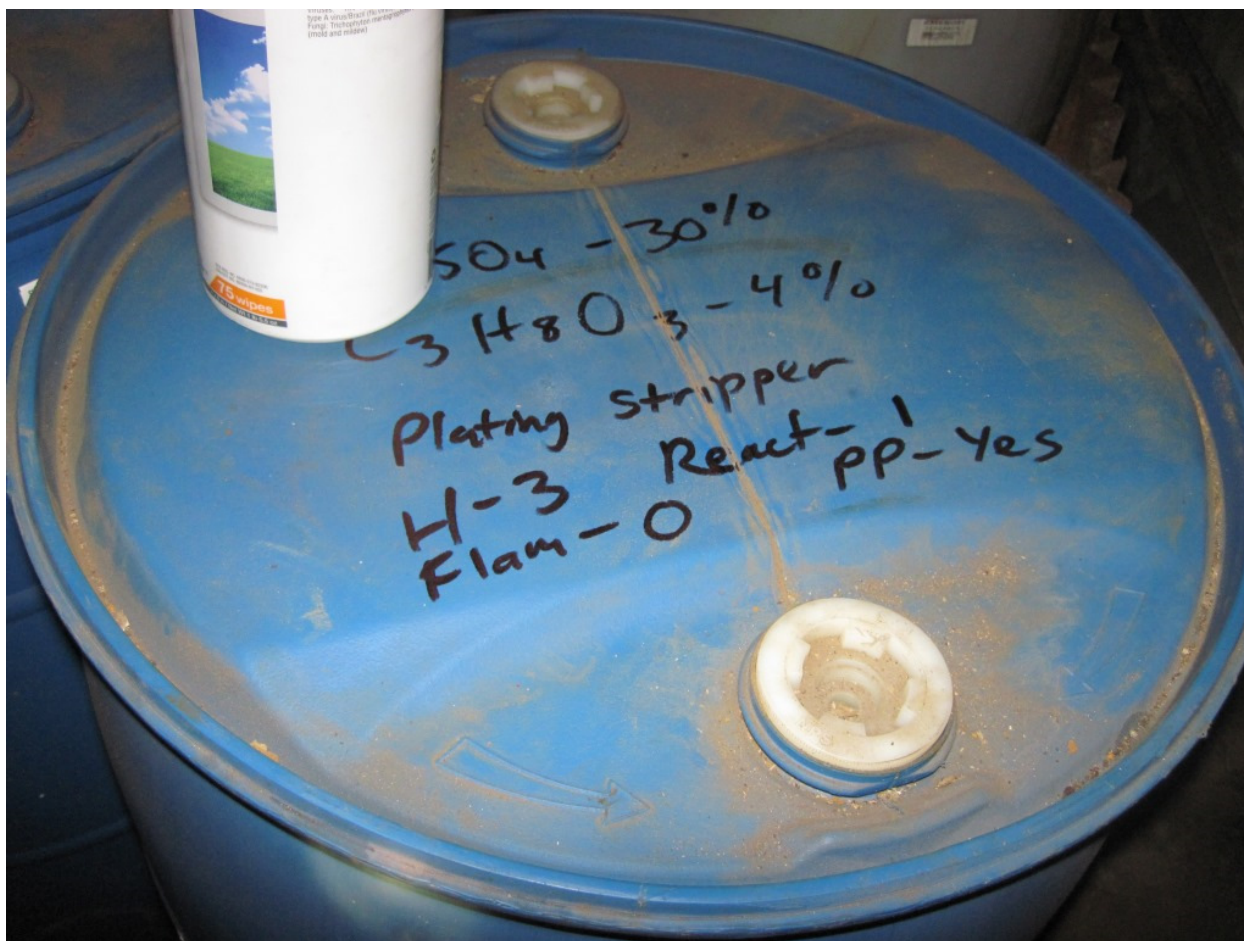
Photo 8: Close-up of the label on a 55-gallon container of sulfuric acid plating stripper located in the former Automatic Zinc Department.

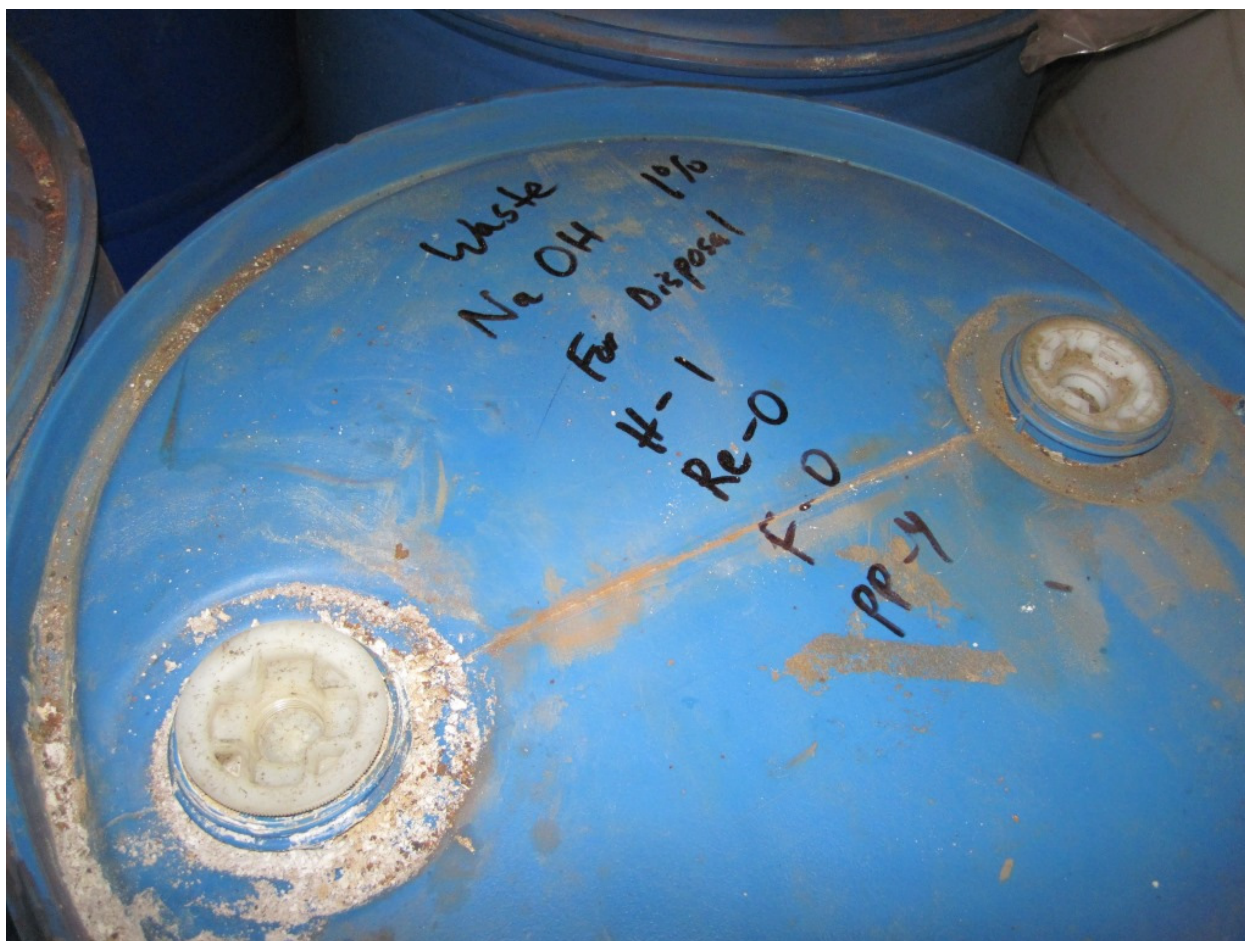
Photo 9: Close-up of Sodium Hydroxide container labeled as “Waste” and “For Disposal” located in the former Automatic Zinc Department.

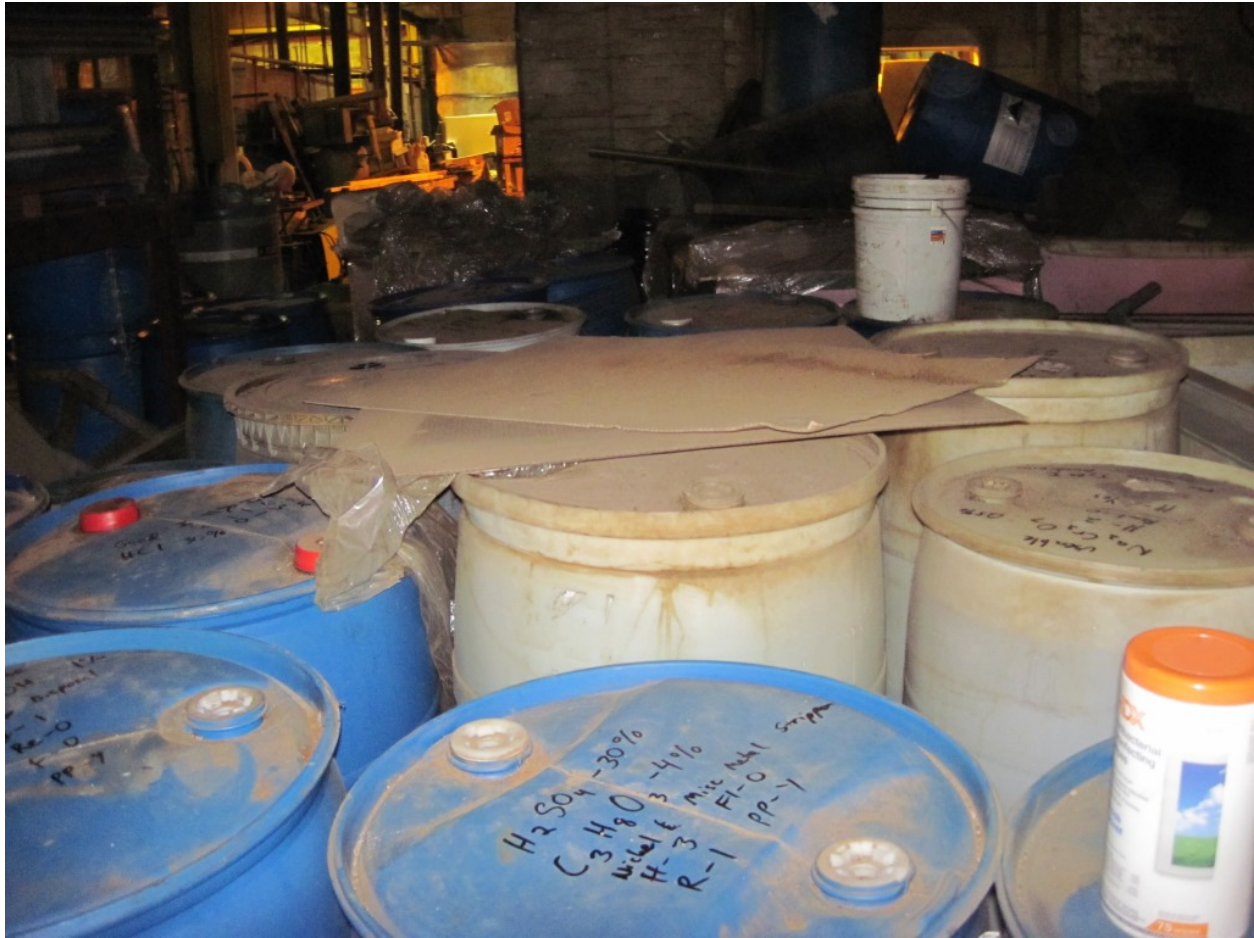
Photo 10: Overview of containers of plating materials located in the former Automatic Zinc Department.

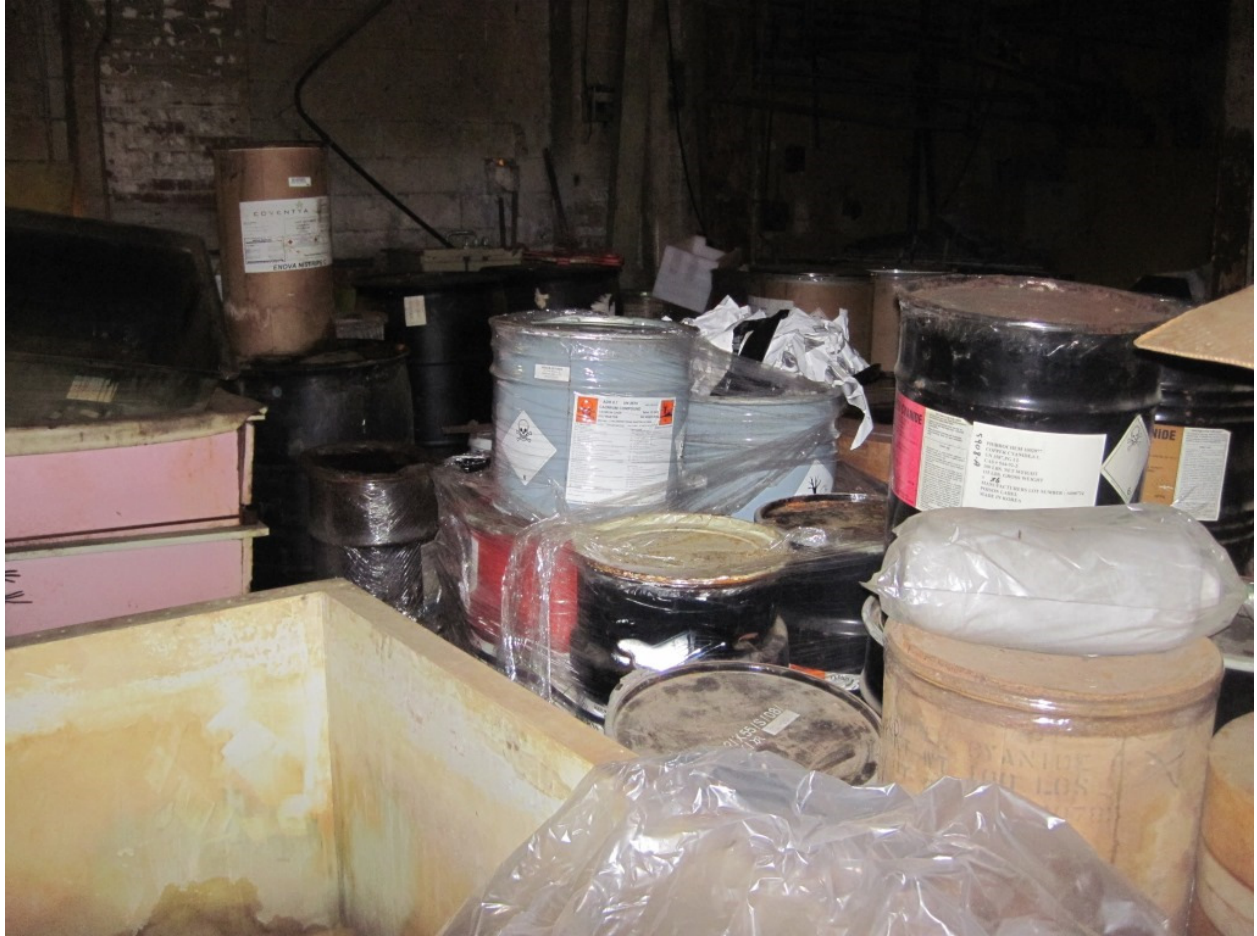
Photo 11: Overview of containers located in the former Automatic Zinc Department.

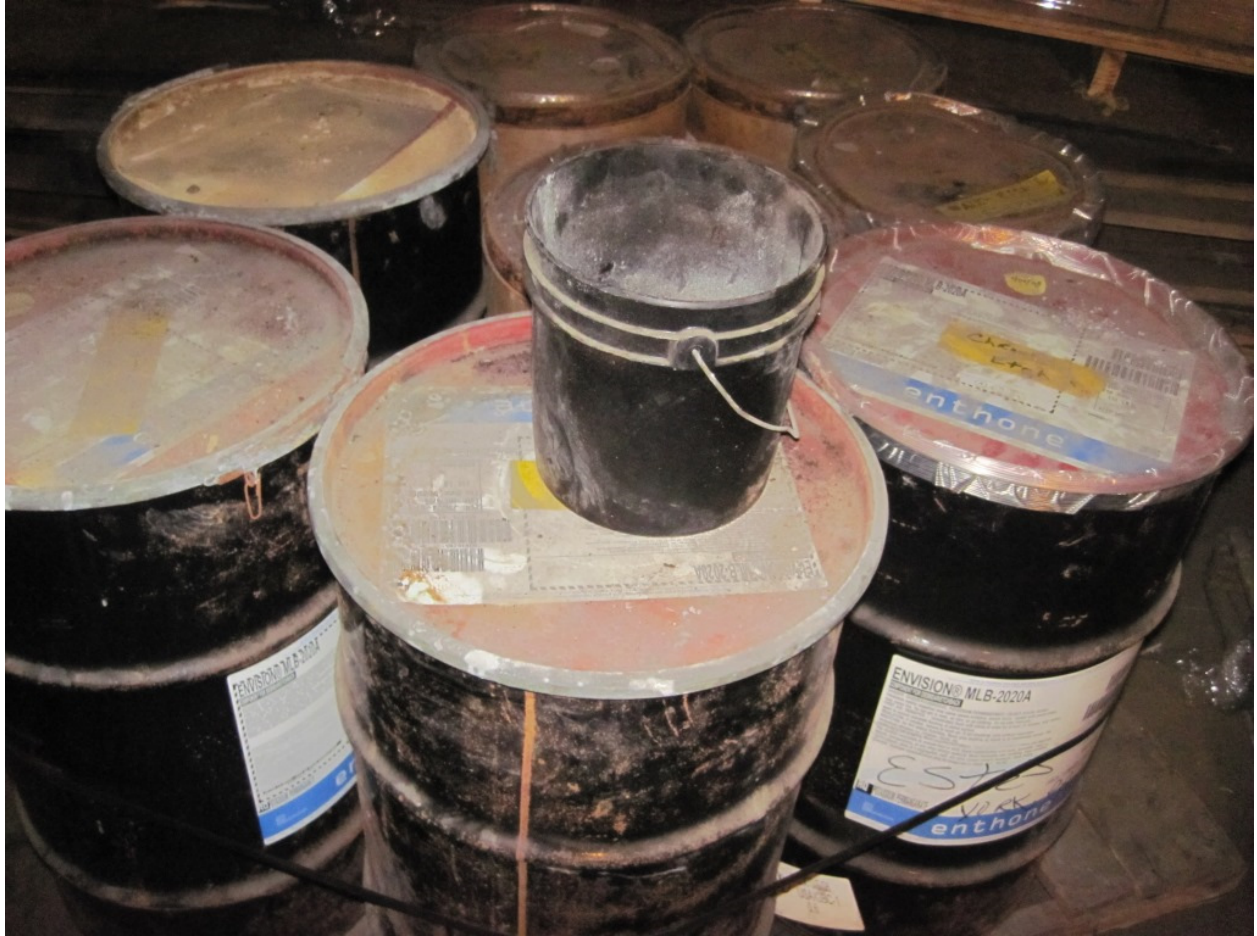
Photo 12: Overview of containers located in the former Automatic Zinc Department.

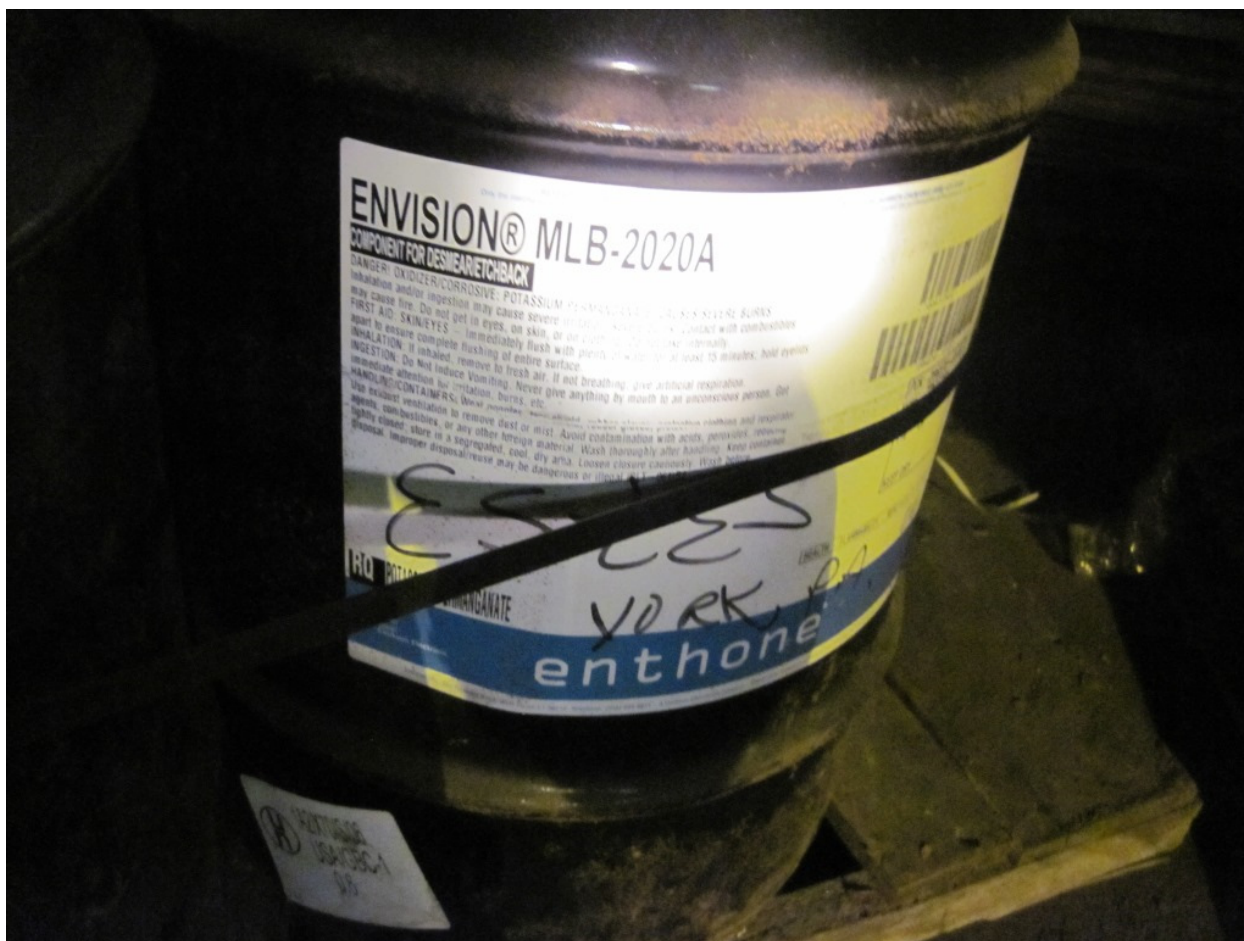
Photo 13: Close-up of product label on a container, as seen in Photo #12 above.

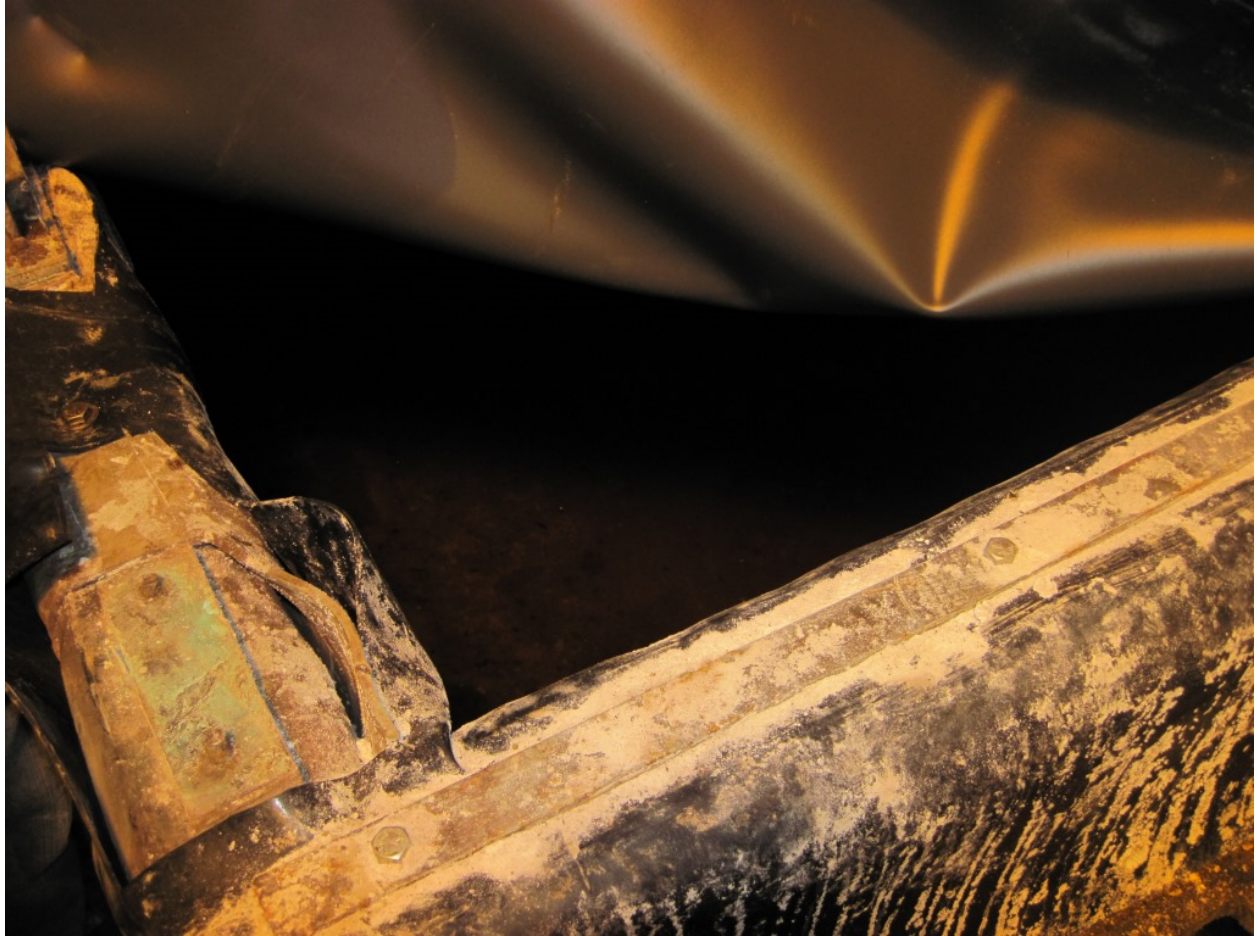
Photo 14: Close-up of a partially filled and covered tank of zinc-chloride solution located in the Zinc Hoist and Cadmium Hoist department.

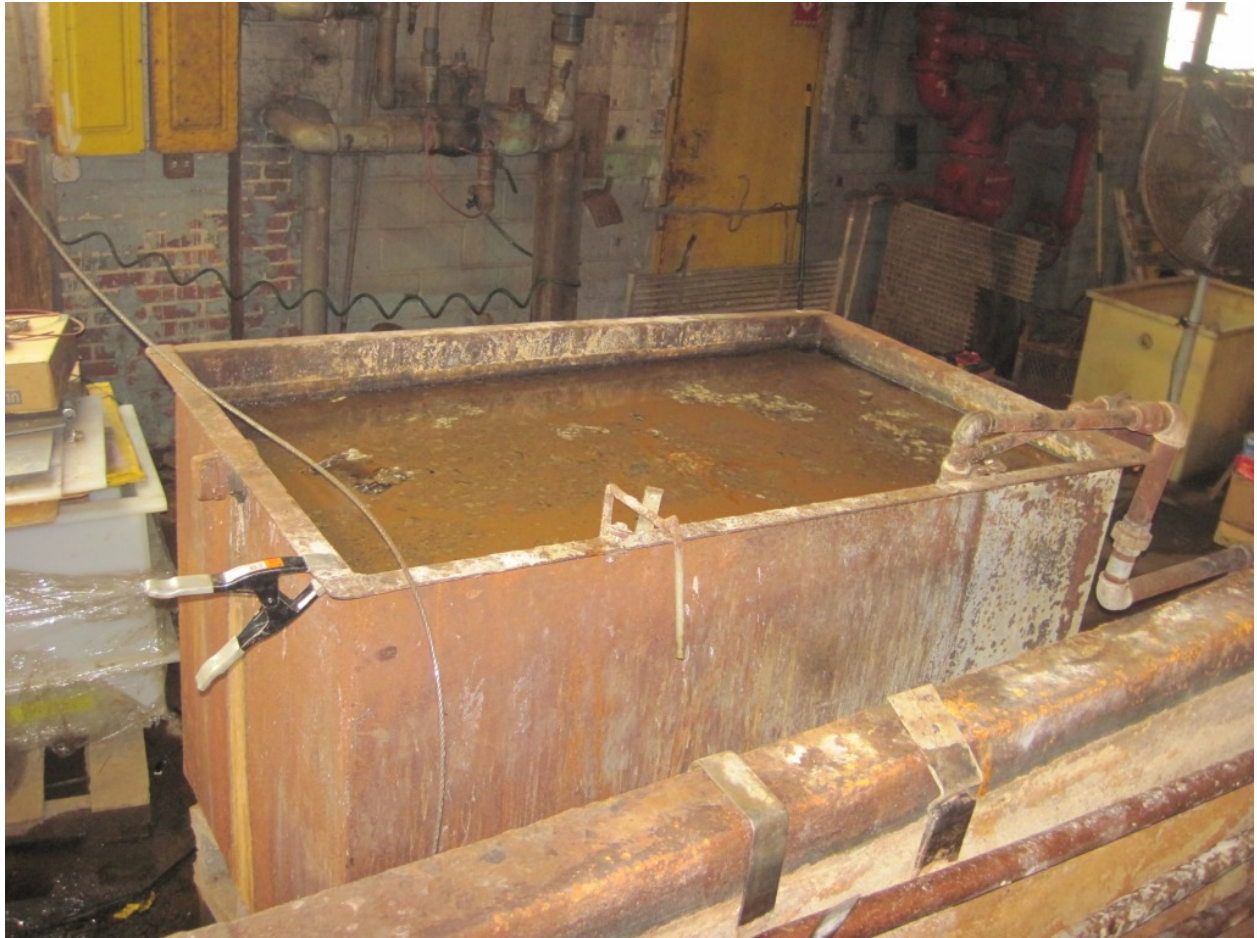
Photo 15: Overview of the electro cleaner tank located in the Zinc Hoist and Cadmium Hoist department.

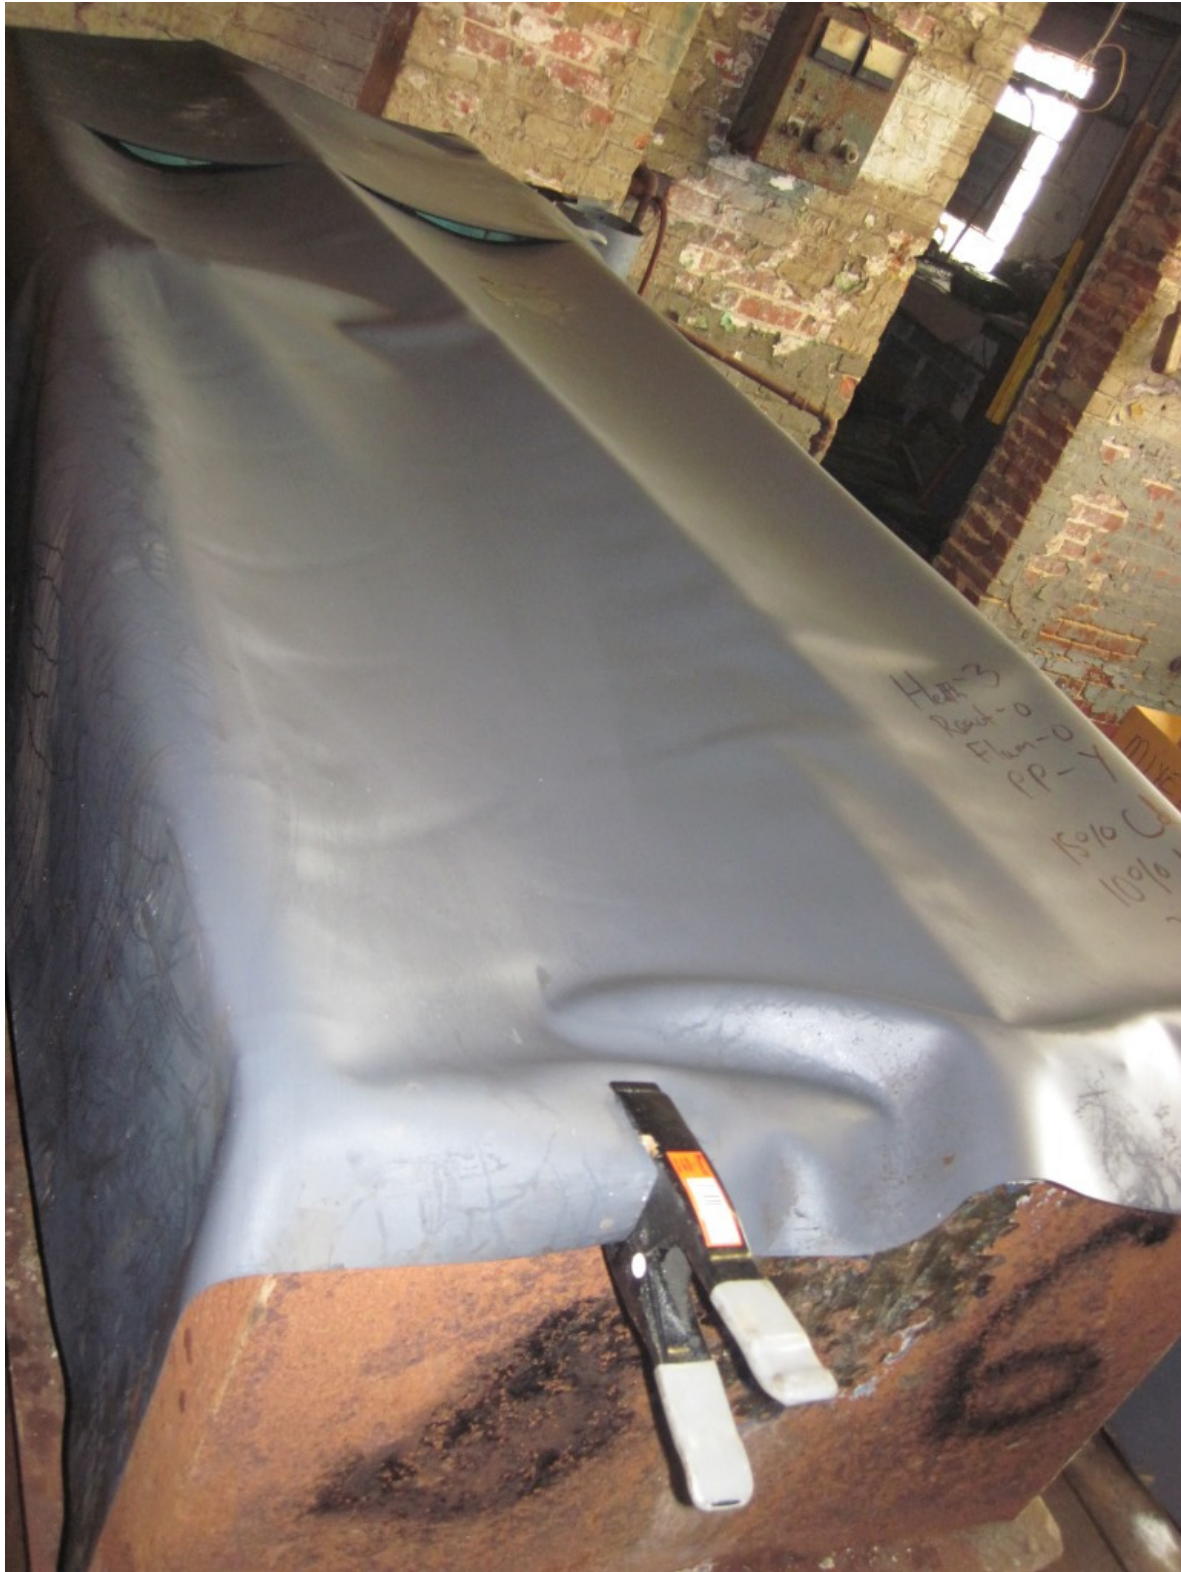
Photo 16: Overview of the covered cadmium oxide plating tank.

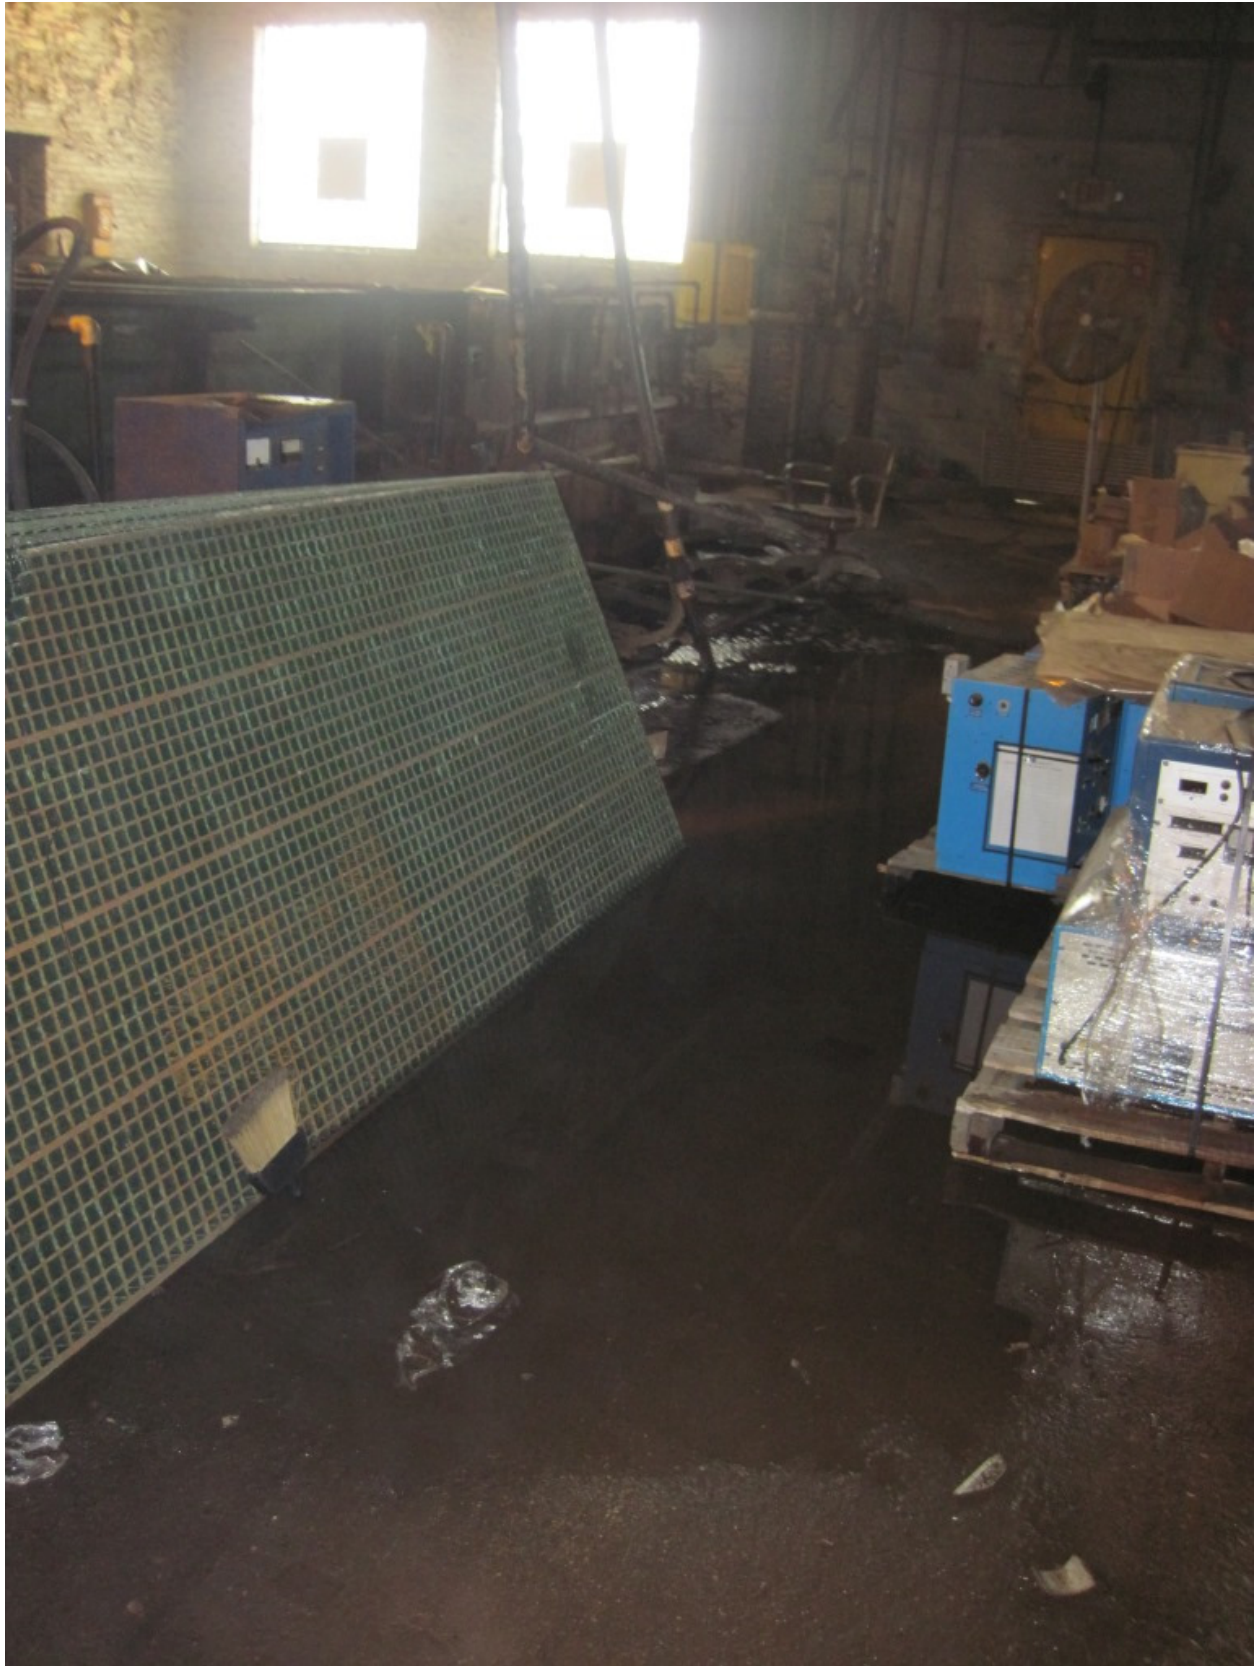
Photo 17: Liquid on the ground near the former Zinc Barrel Line.

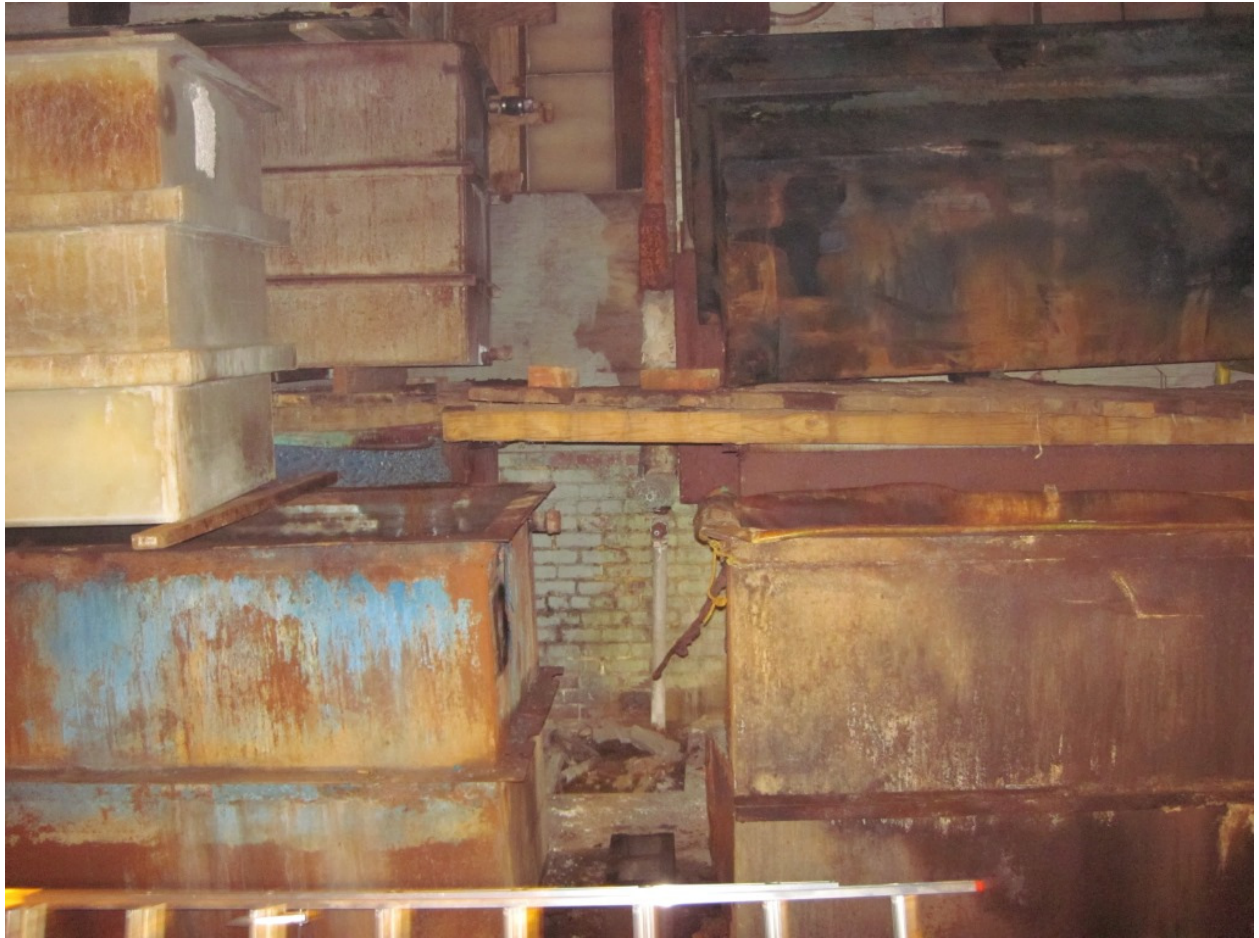
Photo 18: Tanks stacked next to the former Zinc Barrel Line.
